Fresenius Medical Care SERVICE BULLETIN

Equipment: 2008H
Bulletin: 00-FRH-001
Subject: Potential Hydroblock Cover Leak

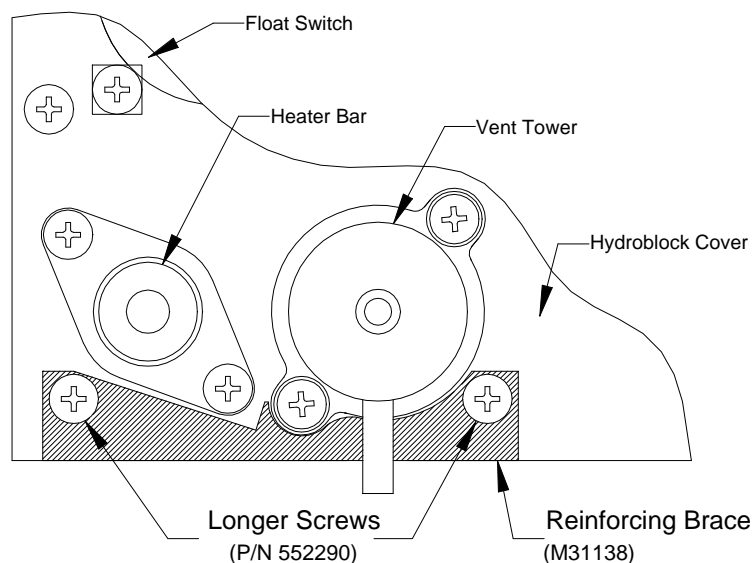
Fig 1

There is a potential for the hydroblock to develop a leak between the cover and body. The rear of the cover may warp between the heater bar and the vent tower. Since there is minimum water pressure at this point, the leak could be very small. Leakage in this area has no effect on the operation of the machine. If during a service call wetness or evidence of leakage is noticed in this area, install a reinforcing brace as described in this service bulletin.

Install the reinforcing brace (M31138) to the top of the hydroblock cover using longer screws (552290). Refer to figure 1 for correct placement.

Note: Do not overtighten the longer screws when installing the reinforcing brace. Only tighten them enough to remove the warp in the hydroblock cover.
